**Flood Control Project Maintenance  
Levee Inspections**

## Maintenance Issue Types Only, Levee Inspection Report By Mile - Spring 2015

### Levee District No. 0003 (Glenn County)

| Waterway | Bank | Unit Miles | Inspection Start/End | Inspector |
|---|---|---|---|---|
| Unit No. 01 Glenn County Sacramento River | Left | 11.97 | 04/29/2015<br>04/29/2015 | Bob Duffey |

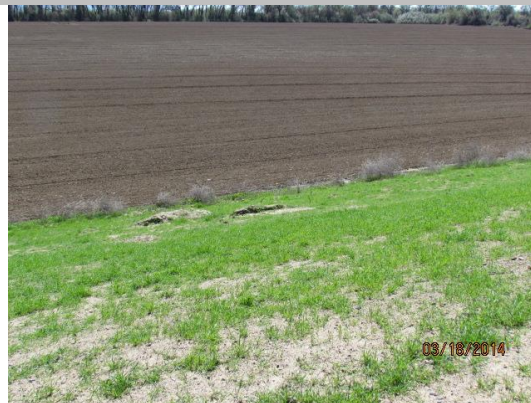
Photo 1 of 1 : SP\_2015\_LD0003\_27\_55\_20150310\_00024.jpg

View of the rodent activity along the w/s slope.

| Exterminate rodents and backfill and compact or grout burrows. | | | | | |

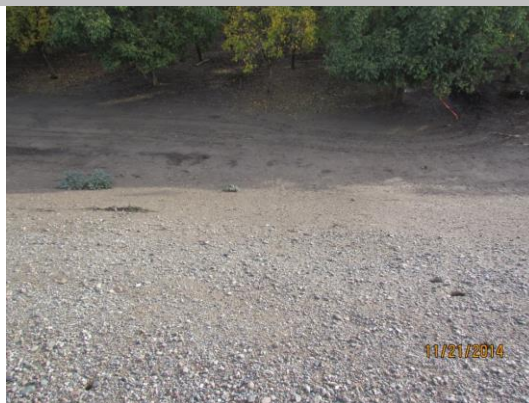
Photo 1 of 1 : SP\_2015\_LD0003\_27\_13\_20150310\_00008.jpg

| No rodents visible, but rodent burrows visible; need to backfill and compact or grout burrows. | | | | | |

View of the rodent holes along the waterside slope.

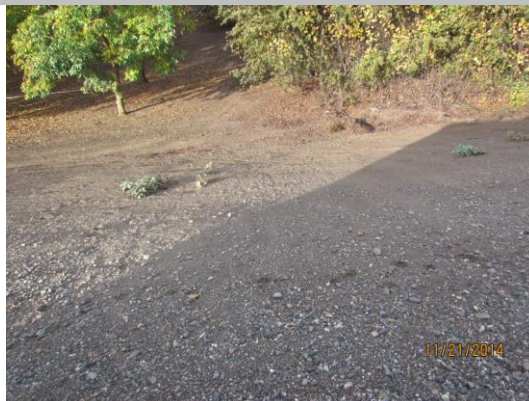
Photo 1 of 1 : SP\_2015\_LD0003\_27\_47\_20150310\_00021.jpg

| No rodents visible, but rodent burrows visible; need to backfill and compact or grout burrows. | | | | | |

View of the rodent holes along the waterside slope.

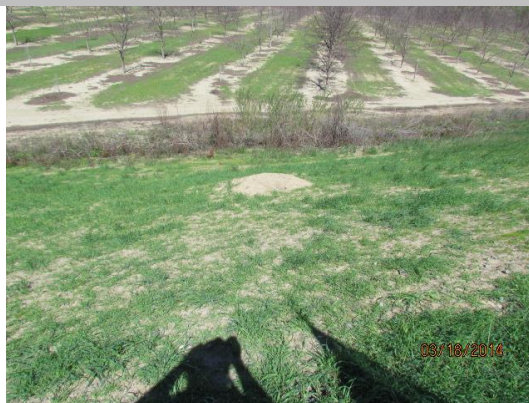
Photo 1 of 1 : SP\_2015\_LD0003\_27\_59\_20150310\_00025.jpg

| No rodents visible, but rodent burrows visible; need to backfill and compact or grout burrows. | | | | | |

View of the rodent activity along the w/s slope.

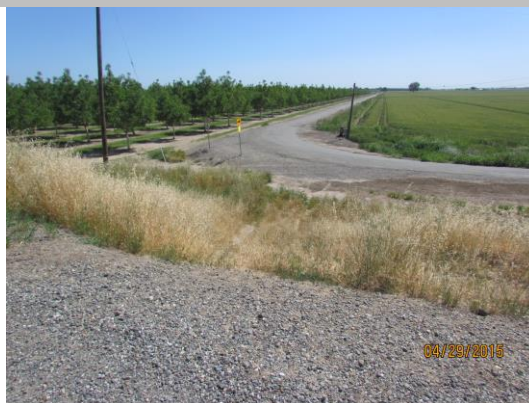
Photo 1 of 1 : SP\_2015\_LD0003\_27\_9\_20150505\_00048.jpg

View of the vehicle erosion along the landside slope.

| Repair the levee slope damaged by vehicle traffic and prevent access where possible. | | | | | |
| Inspector Comments: Repair the erosion along the landside slope. | | | | | |

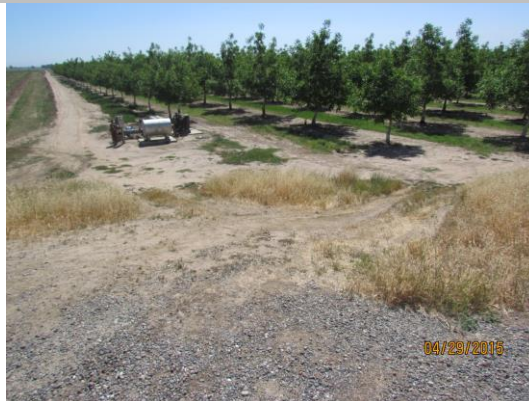
Photo 1 of 1 : SP\_2015\_LD0003\_27\_19\_20150505\_00049.jpg

View of the vehicle erosion along the landside slope.

| Repair the levee slope damaged by vehicle traffic and prevent access where possible. | | | | | |
| Inspector Comments: Repair the vehicle erosion on the landside slope. | | | | | |

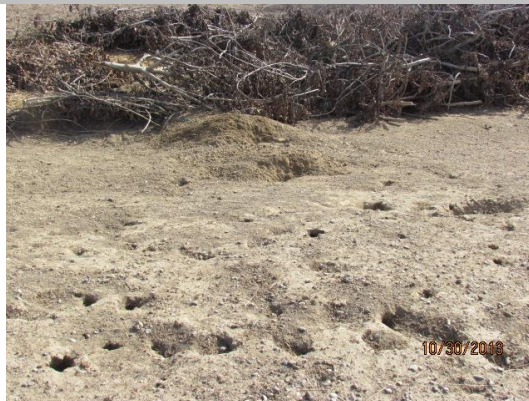
Photo 1 of 1 : SP\_2015\_LD0003\_27\_65\_20150310\_00031.jpg

| No rodents visible, but rodent burrows visible; need to backfill and compact or grout burrows. | | | | | |

View of the rodent activity along the waterside slope.

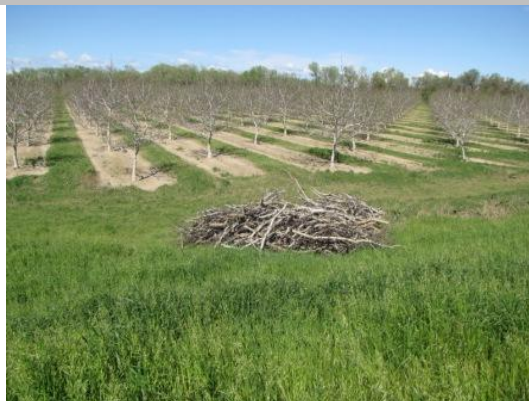
Photo 1 of 1 : SP\_2015\_LD0003\_27\_1\_20150310\_00001.jpg

| Prunings | | | | | |

View of prunings along the W/S toe.

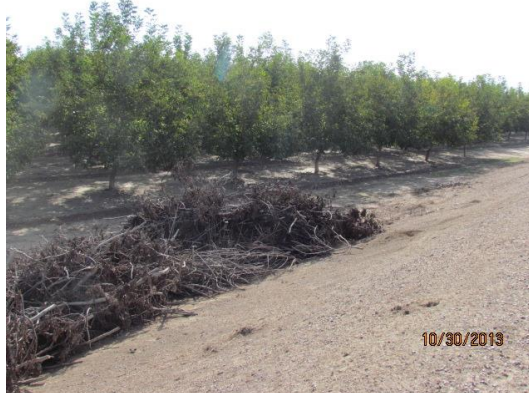
Photo 1 of 1 : SP\_2015\_LD0003\_27\_63\_20150310\_00029.jpg

| Prunings | | | | | |

View of the prunings along the landside toe.

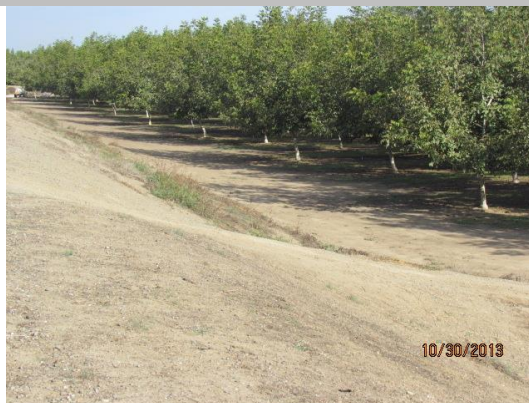
Photo 1 of 1 : SP\_2015\_LD0003\_27\_64\_20150310\_00030.jpg

| No rodents visible, but rodent burrows visible; need to backfill and compact or grout burrows. | | | | | |

View of the rodent activity along the landside slope.

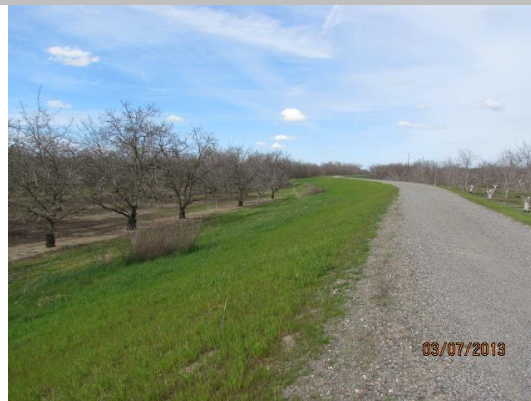
Photo 1 of 1 : SP\_2015\_LD0003\_27\_21\_20150310\_00011.jpg

| No rodents visible, but rodent burrows visible; need to backfill and compact or grout burrows. | | | | | |

View of no rodent activity.

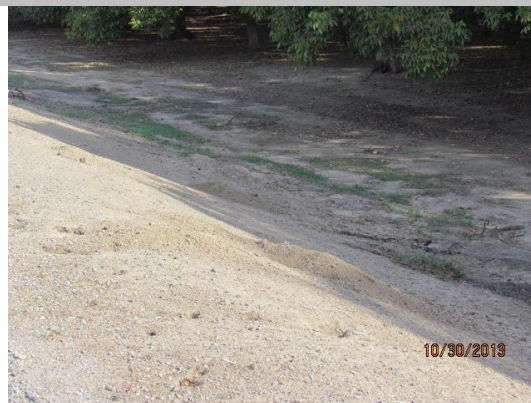
View of the rodent holes along the landside slope.

| No rodents visible, but rodent burrows visible; need to backfill and compact or grout burrows. | | | | | |

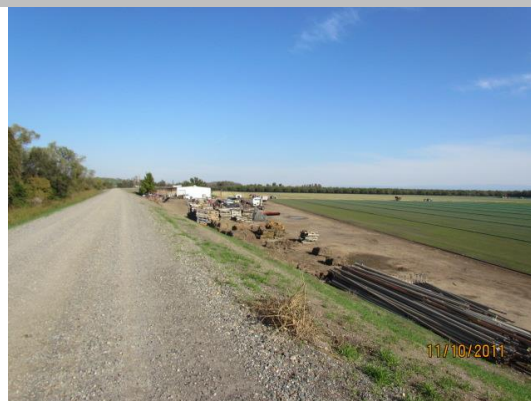
Photo 1 of 1 : SP\_2015\_LD0003\_27\_25\_20150310\_00012.jpg

| Abandoned vehicles | | | | | |

View of the equipment along the L/S toe.

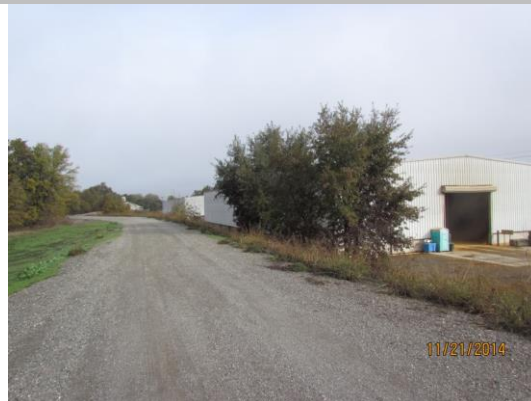
Photo 1 of 1 : SP\_2015\_LD0003\_27\_7\_20150310\_00005.jpg

Trim the trees 5 feet for better visibility.

| Action/Comments | | | | | |
|--|--|--|--|--|--|
| Trim trees to at least five feet above ground level. | | | | | |

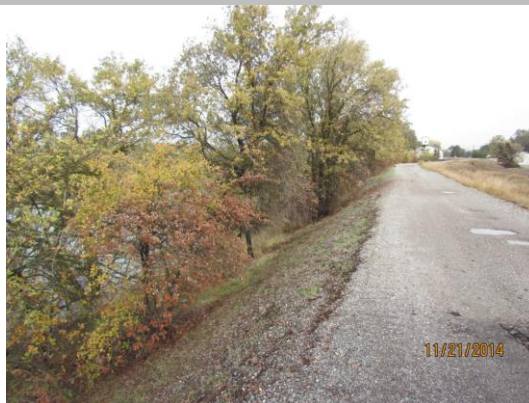
Photo 1 of 1 : SP\_2015\_LD0003\_27\_48\_20150310\_00022.jpg

Trim the trees up 5 feet for better visibility.

| Trim trees to at least five feet above ground level. | | | | | |

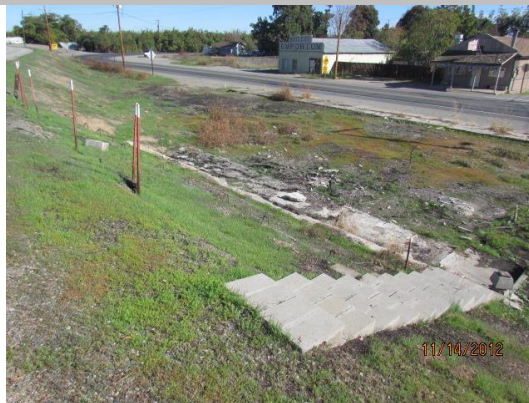
Photo 1 of 1 : SP\_2015\_LD0003\_27\_12\_20150310\_00007.jpg

| Inspector Comments: Building has burned down. | | | | | |

View of concrete stairs & foundation along the slope of the levee.

| Repair slope instability. | | | | | |

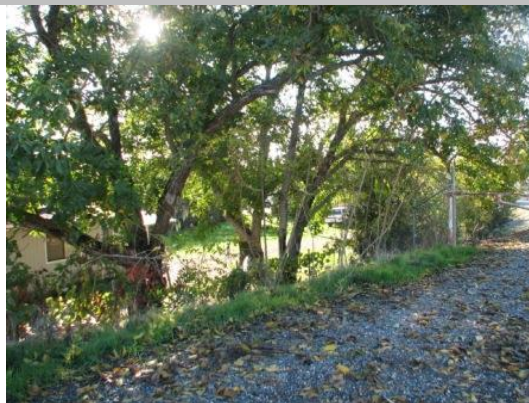
Photo 1 of 1 : SP\_2015\_LD0003\_27\_35\_20150310\_00018.jpg

View of the trees that are hanging over the landside slope of the levee.

| Trim trees to at least five feet above ground level. | | | | | |

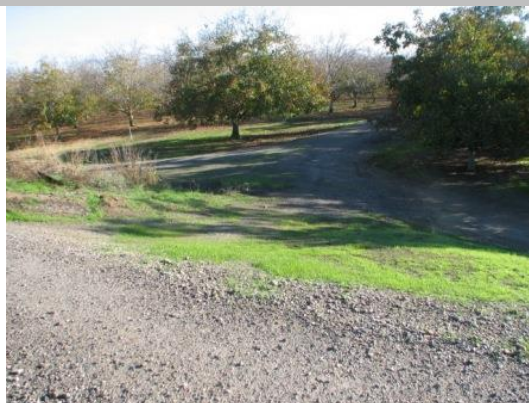
Photo 1 of 1 : SP\_2015\_LD0003\_27\_14\_20150310\_00009.jpg

Vehicle erosion along the slope.

| Repair the levee slope damaged by vehicle traffic and prevent access where possible. | | | | | |

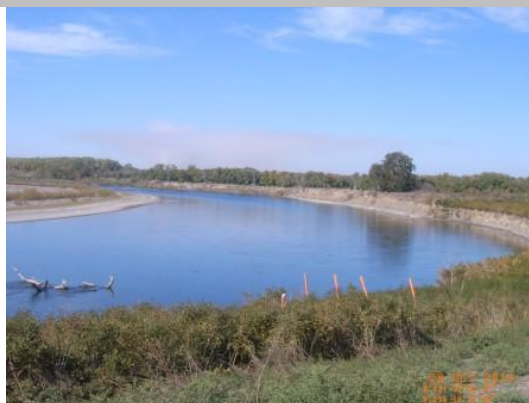
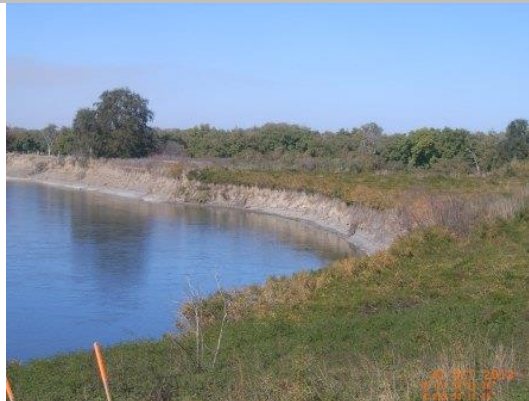
| Inspector Comments: 2007 - Getting close to the levee. Bank is clayey silt with clayey/silty toe. 2008 - Looks a little worse at the upstream end. 2009 - Some new erosion and slumping. 2010 - Some new erosion upstream of site, actively eroding at low flow. New bank swallow colony noted. 2011 - Significant erosion since last year, with an estimated 10 to 15 feet of berm lost. Large sections of the bank have slumped off. 2012 - Part of the site appears to be stabilizing, but still minor slumping in other locations. 2013: Minor new erosion at the toe. [2013 Site ID: SAC_172-0_L] | | | | | |

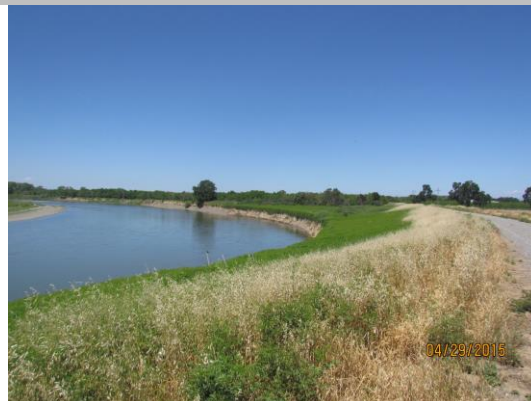
Photo 1 of 1 : SP\_2015\_LD0003\_27\_50\_20150505\_00052.jpg

View of erosion along the waterside toe. Same site as the USACE erosion issue.

| Schedule repair of erosion site prior to the next inspection.<br>Inspector Comments: The erosion site needs to be repaired. | | | | | |

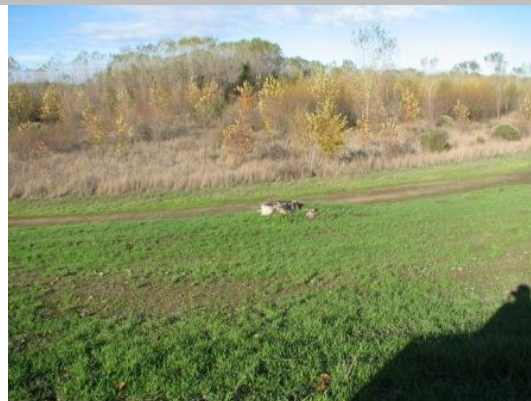
Photo 1 of 1 : SP\_2015\_LD0003\_27\_29\_20150310\_00016.jpg

| Tree stumps. | | | | | |

View of the stump along the toe.

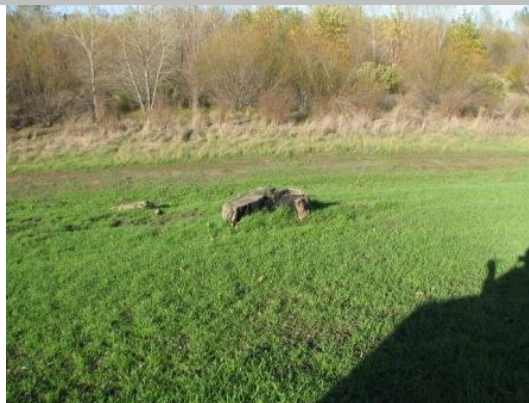
Photo 1 of 1 : SP\_2015\_LD0003\_27\_30\_20150310\_00017.jpg

| Tree stumps. | | | | | |

View of the stump along the slope.

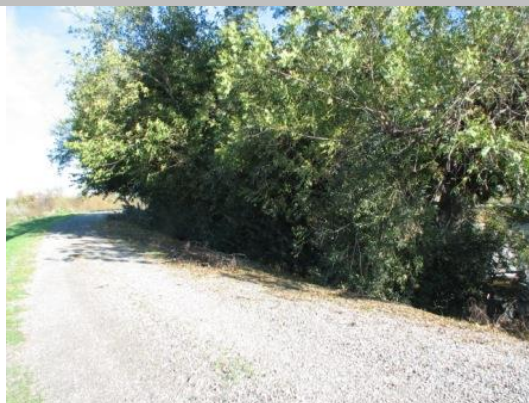
Photo 1 of 1 : SP\_2015\_LD0003\_27\_4\_20150310\_00003.jpg

View of the trees along the slope.

| Thin trees to allow visibility of the ground and room to flood fight. | | | | | |

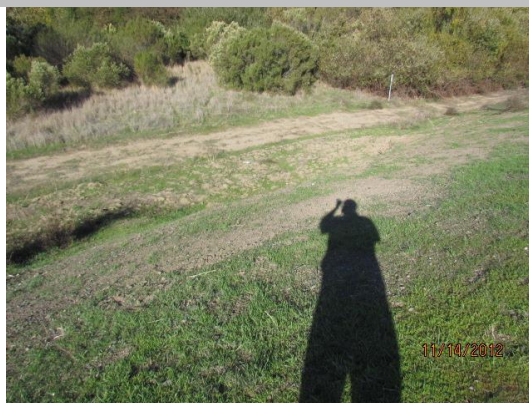
Photo 1 of 1 : SP\_2015\_LD0003\_27\_6\_20150310\_00004.jpg

View of the vertical cut along the w/s toe.

| Repair slope instability. | | | | | |
